Manhole Inspection Summary

Manhole # S19CC_002MH

Insp Date: **10/19/07 1:54 PM**

Location Address: **1925 RIGGS AVE**

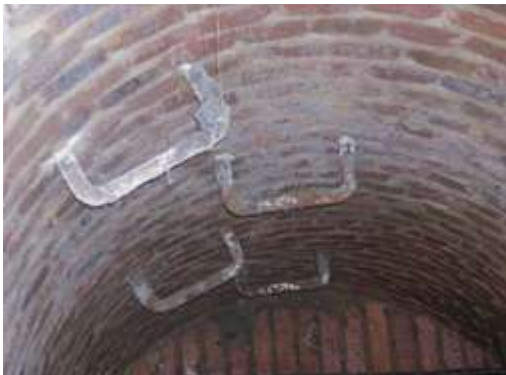
Defect 4

Count: **6** Missing: **0** ☒ **Corroded**

CORRODED STEPS

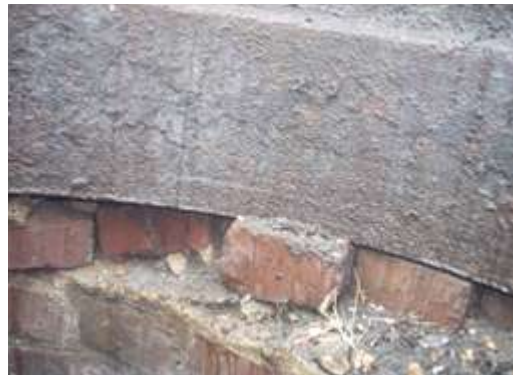
Defect 3

Condition: ☐ Sound ☐ Cracked ☐ Root Intrusion ☒ **Loose Brick** ☒ **Deteriorated**

LOOSE CORBEL BRICKS,
DETERIORATED CORBEL

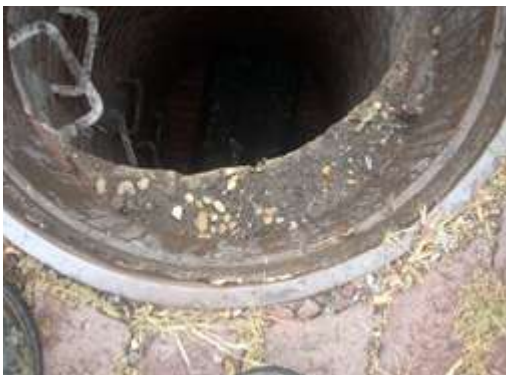
Defect 2

Offset: **3** (in.)

FRAME OFFSET

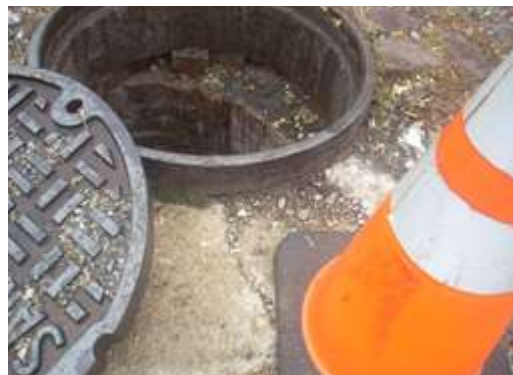
Defect 1

Diameter: **24** (in.) Length: (in.) Dist A/B Grade: **3** (in.)

GRADE ADJUSTMENT

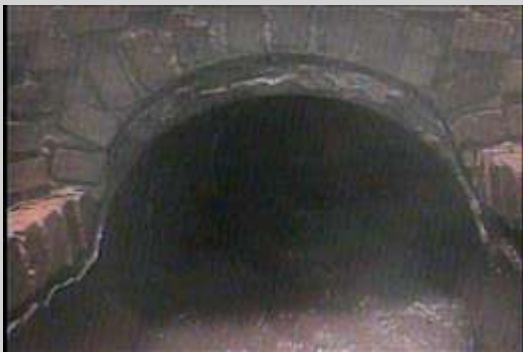
12 O'Clock Outflow

27 in. Circular Gravity Sewer
Pipe Out @ 12 O'Clock

Pipe Height: **27.6** (in.) Rod and Bar (Angled)
Pipe Material: **Clay** ☐ Pipe Lined
Invert Depth: **12.86** (ft.) Flow Characteristics: **Fast**
Deposits: ☒ None ☐ Mud ☐ Sludge ☐ Debris ☐ Grease
Silt Depth: (in.) Deposits Extent:
Infiltration: **None** Pipe Seal Cond: **Sound**

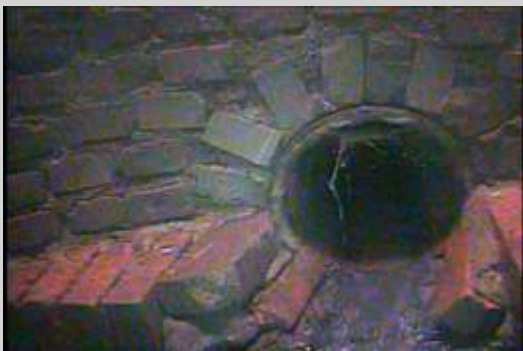
3 O'Clock Inflow

10 in. Circular Gravity Sewer
Pipe In @ 3 O'Clock

Pipe Height: **9.6** (in.) Rod and Bar (Angled)
Pipe Material: **Clay** ☐ Pipe Lined
Invert Depth: **11.29** (ft.) Flow Characteristics: **Slow**
Deposits: ☒ None ☐ Mud ☐ Sludge ☐ Debris ☐ Grease
Silt Depth: (in.) Deposits Extent:
Infiltration: **None** Pipe Seal Cond: **Sound**

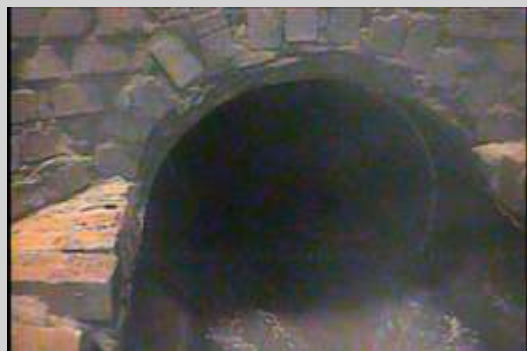
6 O'Clock Inflow

27 in. Circular Gravity Sewer
Pipe In @ 6 O'Clock

Pipe Material: **Concrete** ☐ Pipe Lined

Infiltration: **None** Pipe Seal Cond: **Sound**
